# Aesthetic Restoration for Single-Tooth Implants Multidisciplinary Approach

By David P. Reichwage, DDS

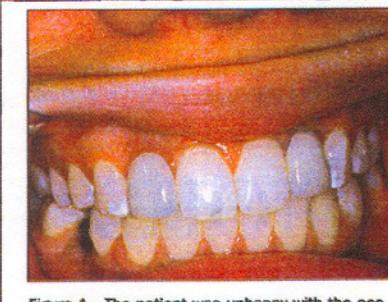
Figure 1. The patient was unhappy with the aesthetics of teeth Nos. 7 and 10.

and 9 was 79% with width of 7.9 mm and length of 10 mm, teeth Nos. 7 and 10 resembled small central incisors (Figure 1). Radiographically, it was noted that the insert for the implant was not seated completely. Also, a periapical lesion was suspected at the apex of tooth No. 7 (Figure 2).

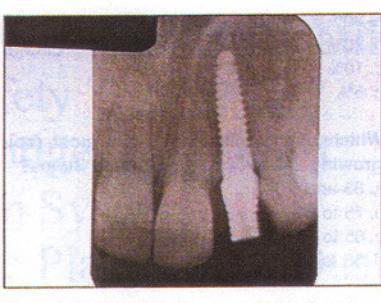
Figure 3. A new implant insert was placed, and proper seating was confirmed.

After administration of topical and local anesthetic and placement of a rubber dam, the porcelain and metal crowns for Nos. 7 and 10 were removed using a diamond 5850-U16 (Brasseler USA) and carbide H34-012 (Brasseler USA) with copious water irrigation. The partially seated insert for the implant was removed. A new insert LA3/4 (Paragon) was placed, and a film was taken to confirm that it fully seated in the implant (Figure 3). This was contoured to have 2.5-mm clearance with the opposing teeth, and torqued into place using 30N/cm.

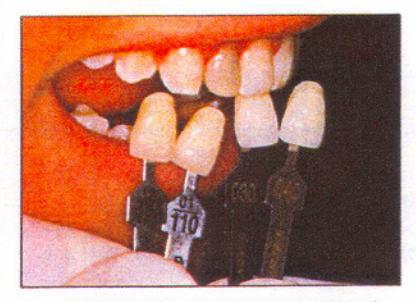
Figure 5. Photos with shade tabs were sent to the laboratory.

Final shade mapping was accomplished with the appropriate shade tabs and photographed with a 35-mm camera. The photos were sent to the lab with shade tabs (Chromascop, Ivoclar Vivadent) (Figure 5). After topical and local anesthetic. the provisional restorations were removed, and the gingival tissue architecture was refined with a diode laser. Upper and lower full-arch impressions were taken using a vinyl polysiloxane light- and heavy-body impression material (Examix, GC America), The cervical and body shades were matched with the appropriate shade tab guide (Figure 6). A stick bite registration was recorded with Blu-Mousse fast set (Parkell), and the provisional restorations were replaced. The written prescription, maxillary and mandibular full-arch impressions, shade mapping, preoperative study models, diagnostic wax-up, 35-mm photos (full-face, natural smile, and close-up) were sent to Sunrise Laboratory.

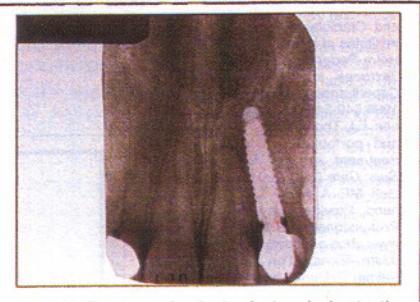
Figure 2. The insert for the implant replacing tooth No. 7 was not seated completely. Also, a periapical lesion was suspected on tooth No. 7.

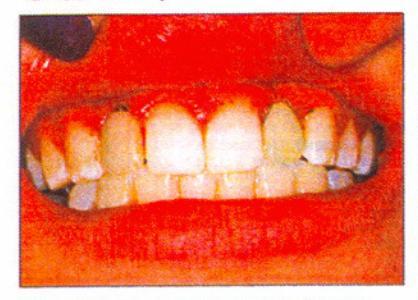
Figure 4. The provisional restorations for teeth Nos. 7 and 10 were cemented in place.

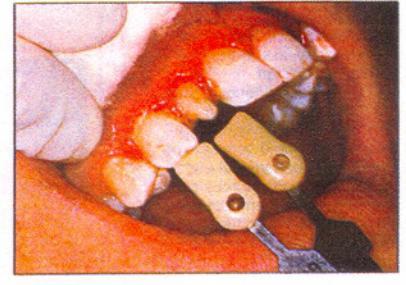
Figure 6. Cervical and body shades were matched with the appropriate shade tabs/guide.
